## Service Information Letter

**AG-SIL-2019-03-EN**
**Issue: 1**
**Dated: 13.09.2019**

All AutoGyro gyroplanes

**Subject: Rotor blade inspection guidelines**
**Safety effect:**

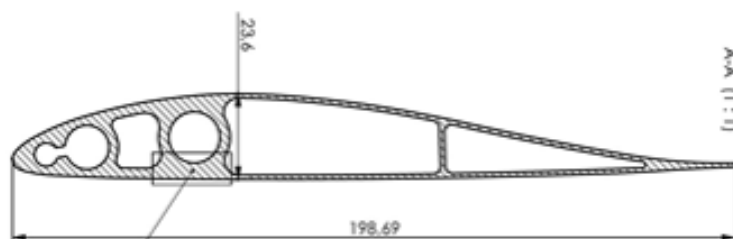
RotorSystem II extrusion.

The blade extrusion inner profile differs between RSI and RSII. See below.

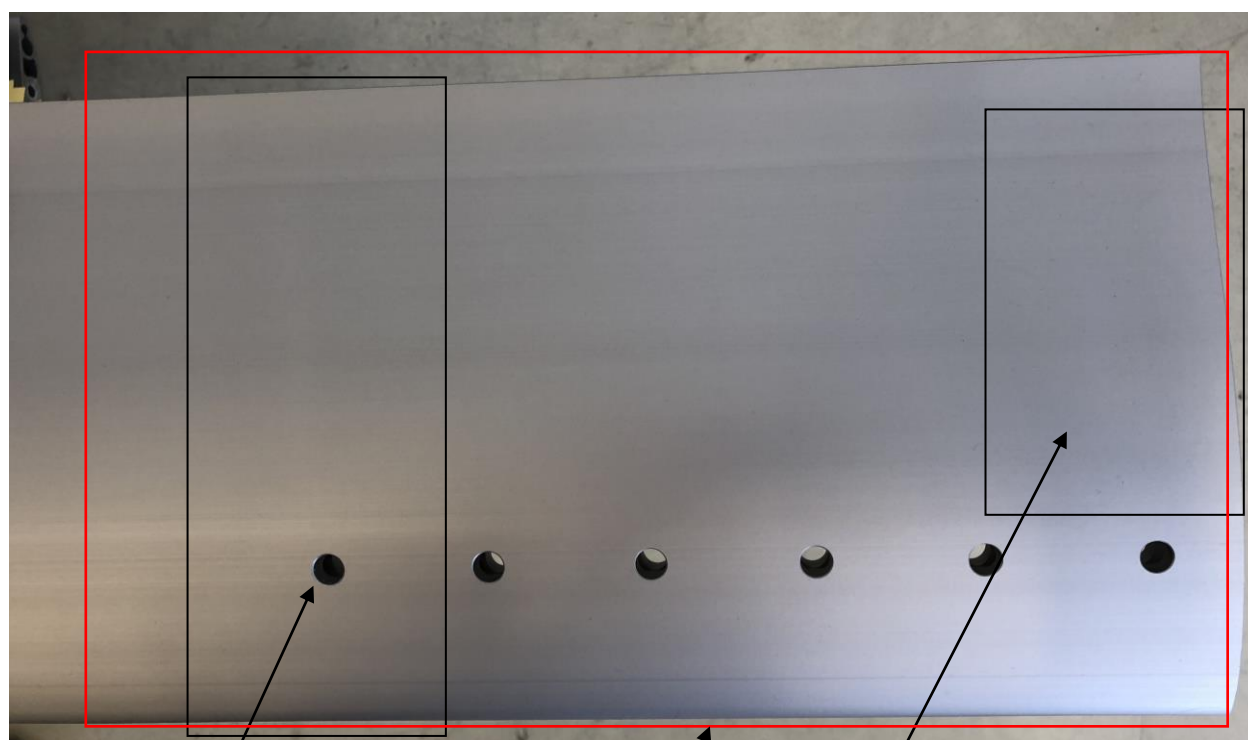
View of the top side of the rotor root (RSII, 6-hole attachment. The same applies to this area on the 9-hole attachment).

By design analysis, the highest tensile load from centripetal forces, and induced bending loads in flight and ground handling, is at the outboard bolt hole. (smallest blade cross section).

Cracks in the outboard bolt hole area in a RotorSystem I is the reason for the establishment of a life limit of 1500 hrs (UK 700hrs).

To date no cracks have been found in this area in RotorSystem II, which is calculated to have a safe life of 2,500hrs.

Outboard bolt hole area. Both upper and lower surfaces must be carefully inspected. No cracks, splits, dents or defects allowed +/-100mm either side of this hole.  
No bending of the blade in any plane permissible in this area.  
See SB-034 for RotorSystem I.

Area of possible crack in upper surface. Inspected either during strip down, or by removing the inner end cap and viewing in side the extrusion end with a bright lamp. See later note and photos.

The entire root area connection to the hub bar is of importance. Holes must be clean and free of burrs and corrosion. Fretting between the clamp profile (that sets the angle of blade incidence to the hub) should be minimal and not rubbing into the blade surface. Light damage to the trailing edge area, rear of the clamp profile, is permissible.

The RotorSystem I blade to hub bar joint must be strip-inspected every 100hrs (due to the lower safe life)  
The RotorSystem II blade to hub bar joint must be strip-inspected every 500hrs (1/5 of the safe life limit).

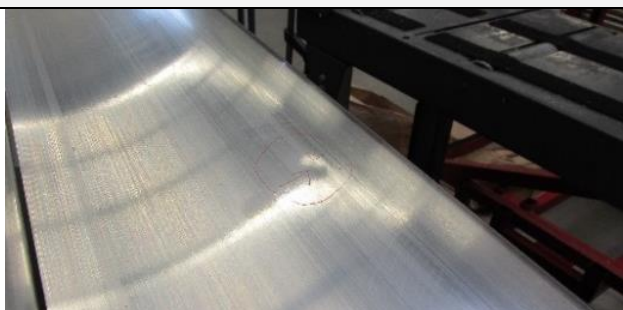
Occasionally a stone or other foreign object enters the rotor disc whilst spinning, resulting in a dent in the leading edge, or in the blade surface. The leading edge is solid aluminium of significant thickness. Small dings can be dressed out only to the basic blade profile. Filling is not permitted. Significant dings within 2m of the hub bar are potential stress raisers and damage left in service must be carefully considered by the inspector for the level of risk. If in doubt, contact [airworthiness@auto-gyro.com](mailto:airworthiness@auto-gyro.com).

Dents in the upper or lower surfaces (such as the photo above) more than 1m from the hub bar up to 10mm in diameter are unlikely to cause a stress raiser and may be left in service and monitored by the user

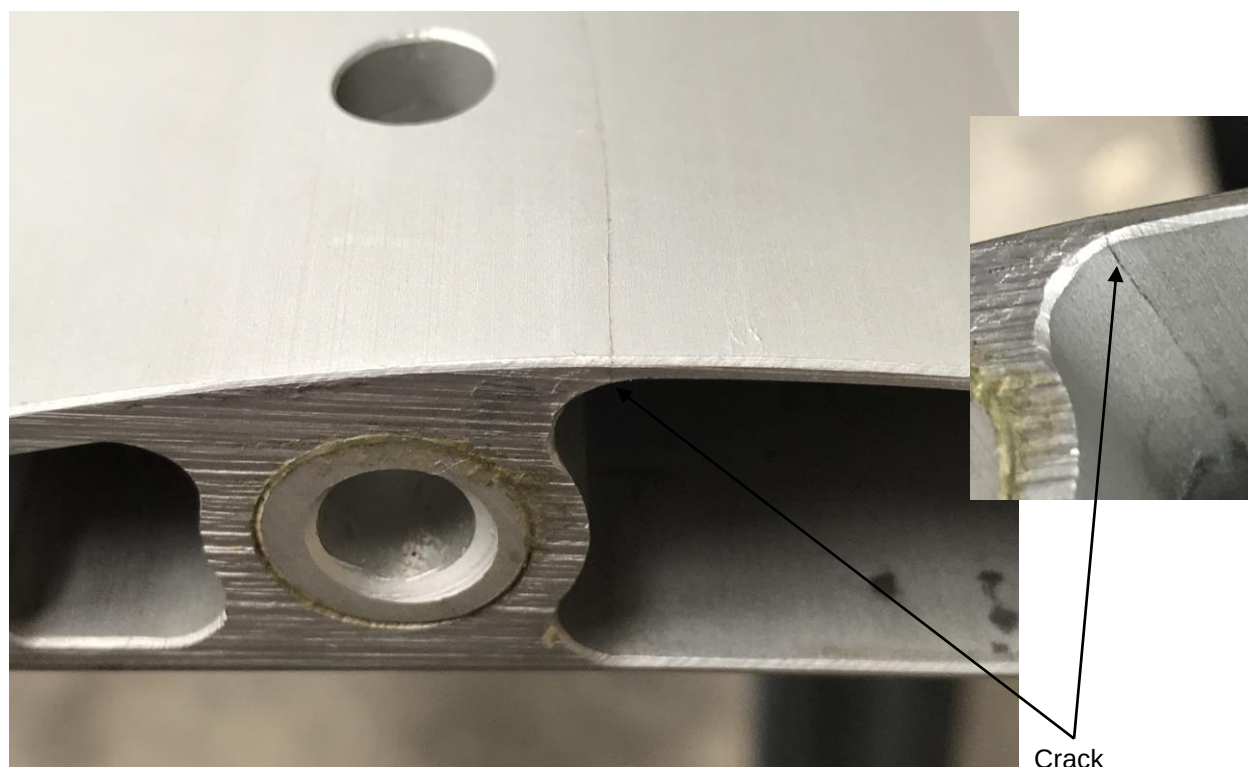
Longitudinal blade root crack, adjacent to bolted area.

Photo of a longitudinal blade root crack, and inset a photo taken viewing from inside the blade with the inner end cap removed.

The presence of such a crack can be easily inspected by removing the blade inner end cap, and viewing with a bright torch.
