| <b>Title: Check For Presence Of Mast Root Drain Hole</b> | | |
| <b>AG-SB-2019-01-A-EN</b> | | <b>Compliance Category:</b> |
| <b>Aircraft type &amp; model:</b><br><br>MTO2017 | <b>Affected Serial number(s):</b><br><br>All MTO2017 models | |

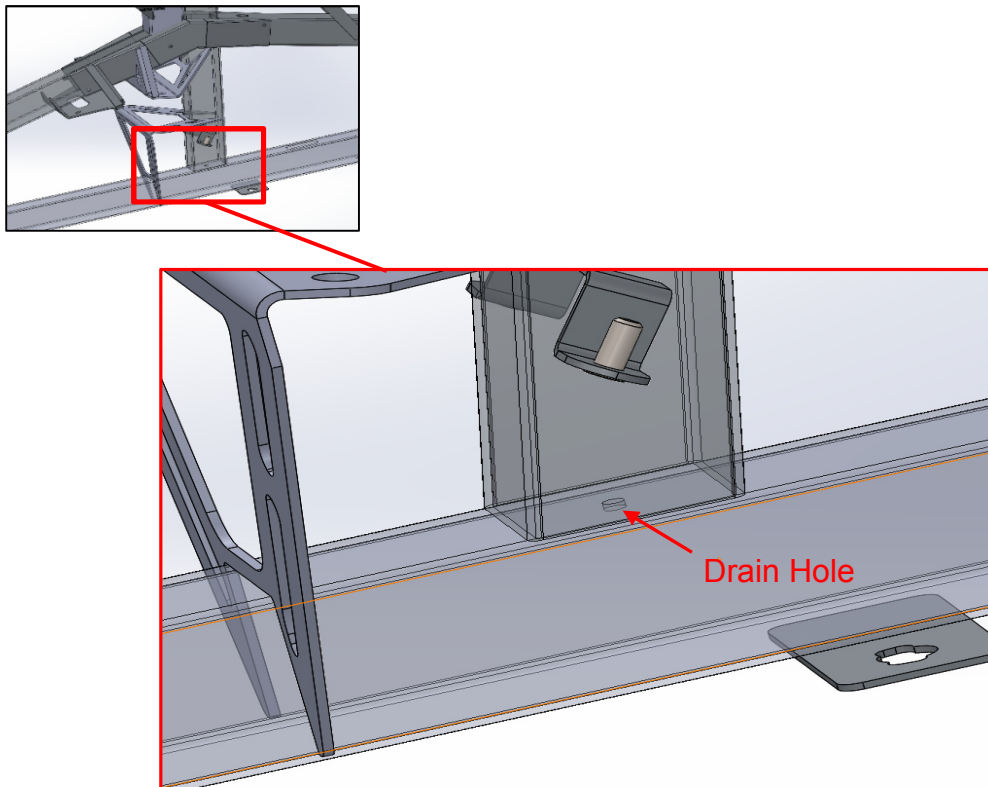
Fig. 1

It has been found that during production of the main frame, the main mast root drain hole (fig 1) may have been left out of the frame assembly on a small number of MTO2017 frames currently in the market.

This may lead to flushing fluids used during the electrochemical polishing process remaining trapped in the forward mast tube.
