| <b>Title: Frame inspection</b> | | |
| <b>AG-SIL-2022-1-EN</b> | | <b>Released:</b><br><br>15 <sup>th</sup> August 2022 |
| <b>Aircraft type &amp; model:</b><br><br>MTOsport 2017 | <b>Affected Serial number(s):</b><br>All MTOsport 2017 | |

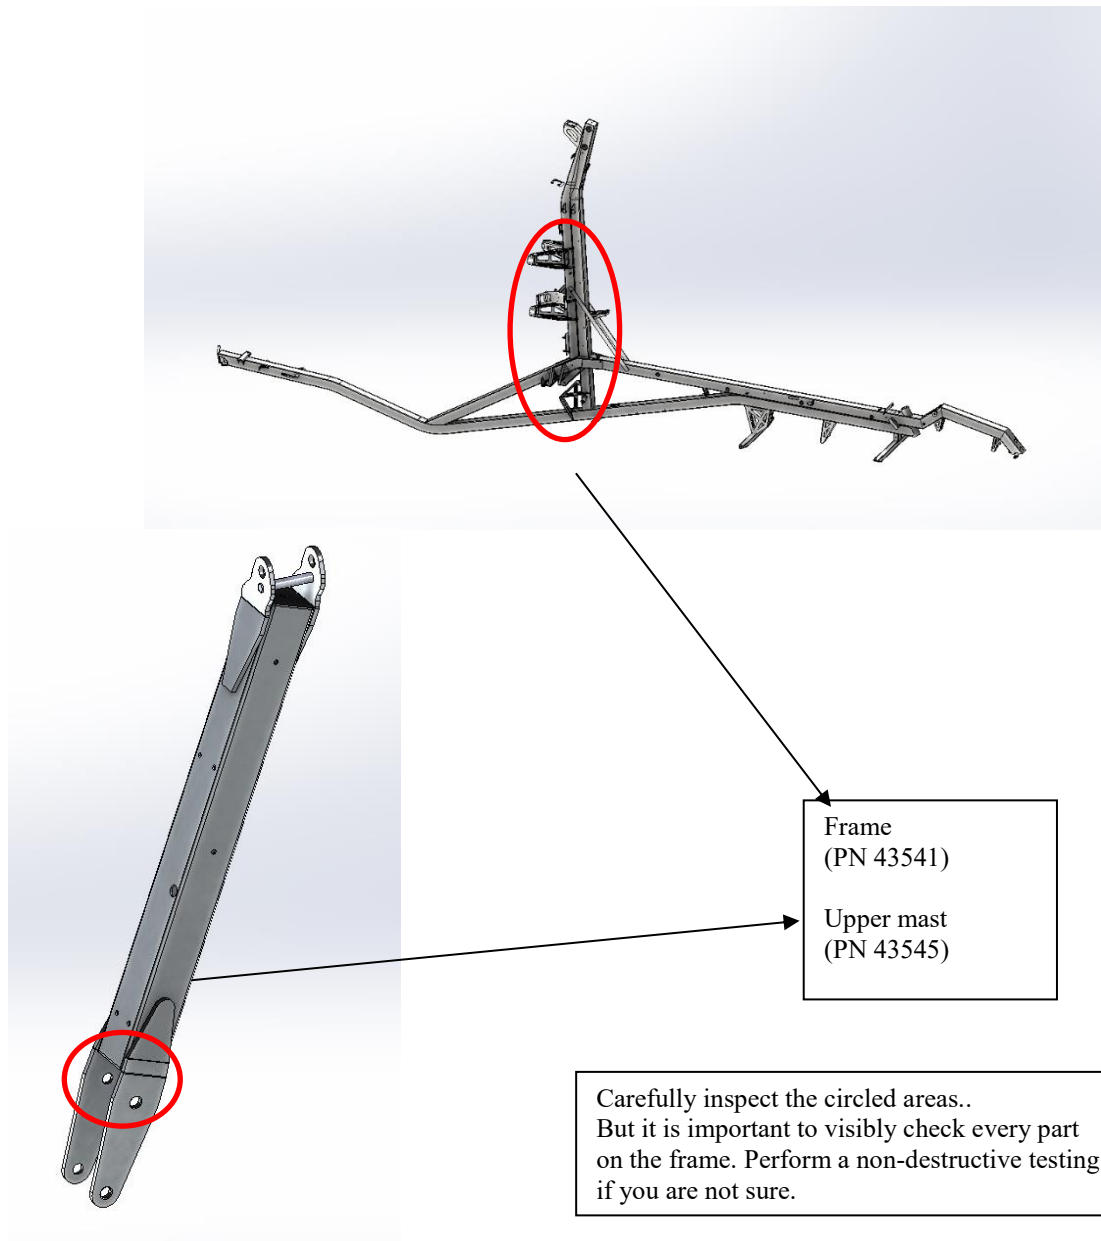
Possible damages can occur beneath the lower engine mount, on the bracket for the undercarriage and on the brackets of the upper mast (PN 43545) in case of the two piece frame.

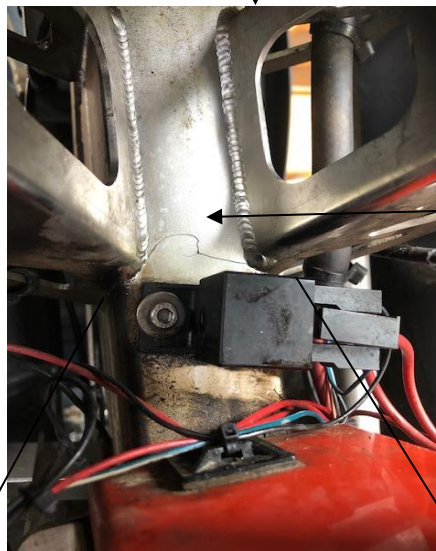
Crack between the engine mount LH and RH

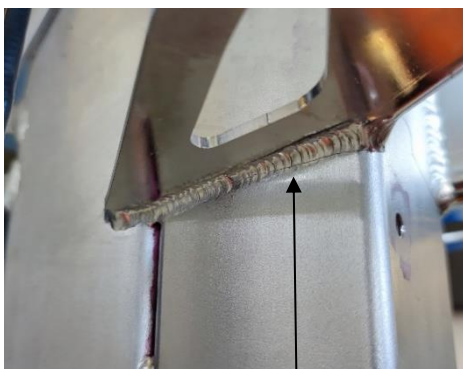
Crack on the underside L/H

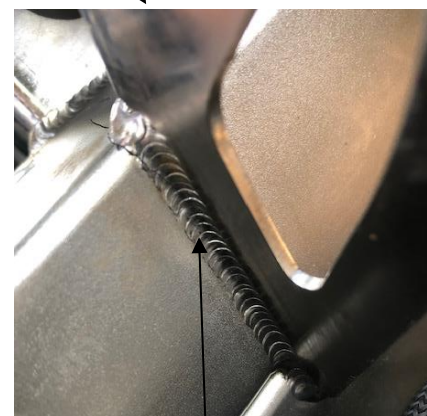
Crack on the underside R/H
