| <b>Title: Frame inspection</b> | | |
| <b>AG-SIL-2022-1-EN</b> | | <b>Released:</b><br><br>15 <sup>th</sup> August 2022 |
| <b>Aircraft type &amp; model:</b><br><br>MTOsport 2017 | <b>Affected Serial number(s):</b><br>All MTOsport 2017 | |

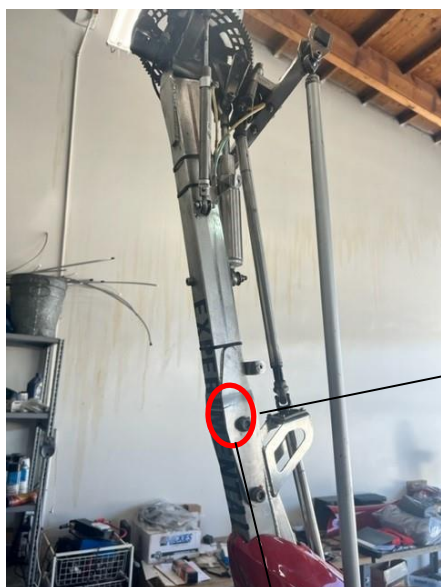
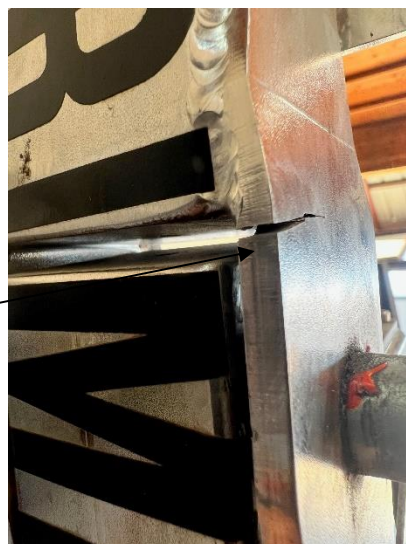
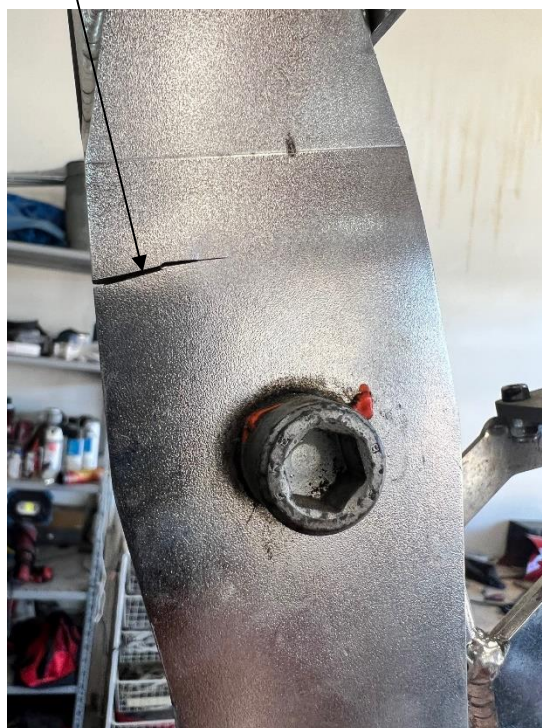
Crack on the underside R/H

Standard tools. Inspectors are recommended to have available suitable lighting and equipment to be able to view the airframe effectively. A suitable dye-penetrant process should be employed in accordance with the manufacturer's instructions should cracks be suspected but not clearly visible.
